BS 8458:2015: Annex C

Method for Measuring the Capability of a Watermist System to Control a Fire – “Room Fire Test for Watermist Systems with Automatic Nozzles”

A Report To: Plumis Ltd.

Document Reference: 514130

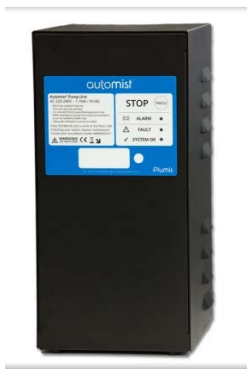
Pump	General description	Automist high pressure pump. 6.0l/min, 120 bar maximum working pressure
	Product reference	"Automist Pump AP08"
	Name of manufacturer	Plumis Ltd.
	Power supply	230VAC 1.7kW
	Electrical connection	Electrical connection via recessed screw terminals behind access panel on pump enclosure
	Filters	External inlet filter (Mesh 80)
	Strainers	Strainer at water inlet (part of the solenoid)
	Photograph

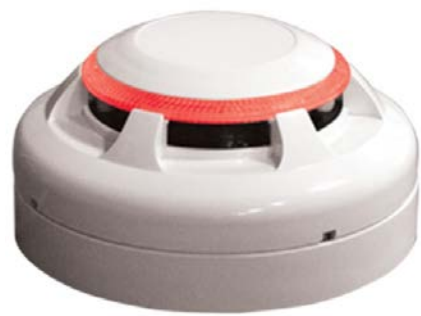
Smoke alarm	General description	Photoelectrical optical smoke detector, 2 wires, conventional, EN 54-7
	Product reference	"Automist Wired Smoke Detector DT02"
	Name of manufacturer	Plumis Ltd.
	Colour	White with red LED
	Photograph

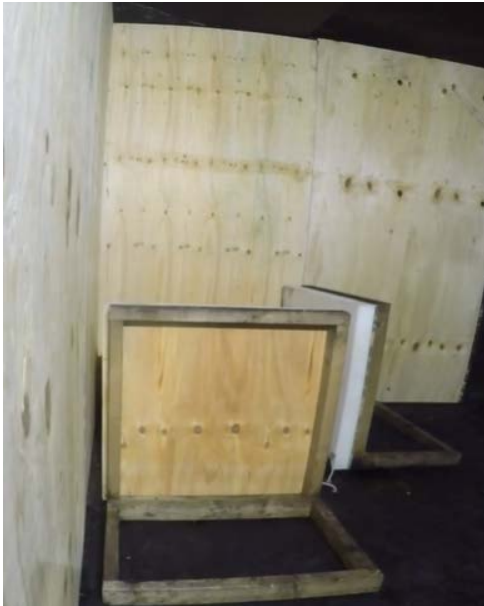
Photographs of ignition and fuel package before test 1

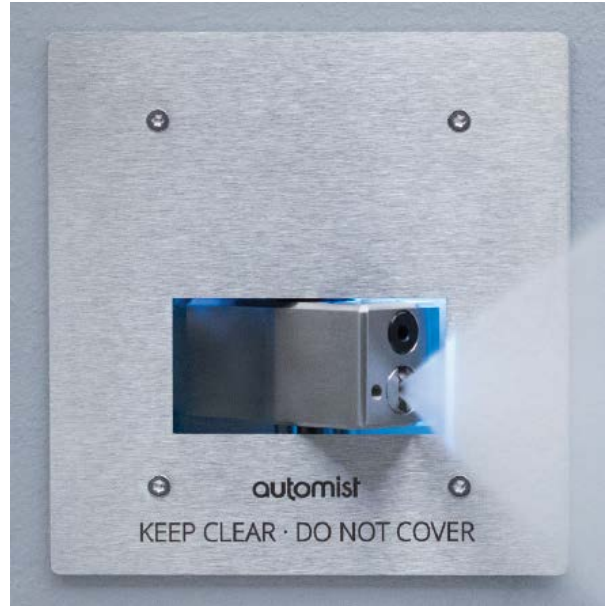
Photograph of nozzle

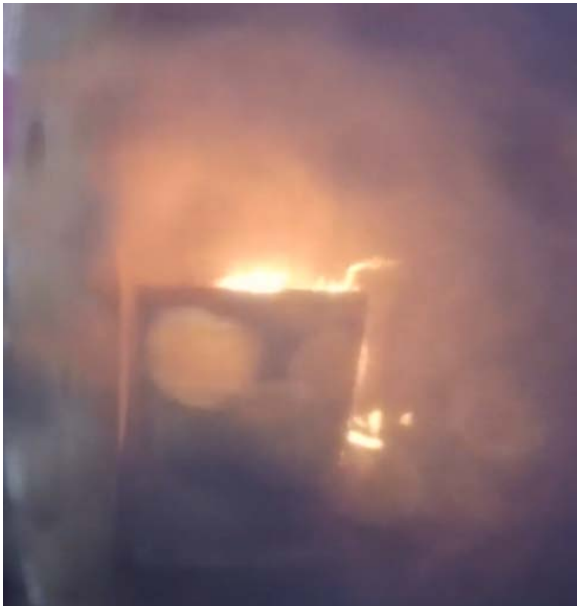
Photograph of system during test 1
